**ARCHAEOLOGICAL BUILDING
RECORDING OF A BARN AND STABLE BLOCK AT DOVECOTE, PILTON
ROAD, WADENHOE,
NORTHAMPTONSHIRE**

**A Report by Paul Stamper Heritage
March 2019 (with Addendum July 2019)**

The Wadenhoe Trust has been granted LBC (18/02319/LBC) to convert a stone barn into office accommodation and a stable into a dwelling. Both adjoin Wadenhoe's Grade II-listed dovecote and lie within Wadenhoe's conservation area. Paul Stamper Heritage was commissioned by the scheme's architect Colin Moore on behalf of the Trust to undertake Level 2 recording work as set out in a WSI approved by NCC following a brief issued by NCC dated 31 January 2019.

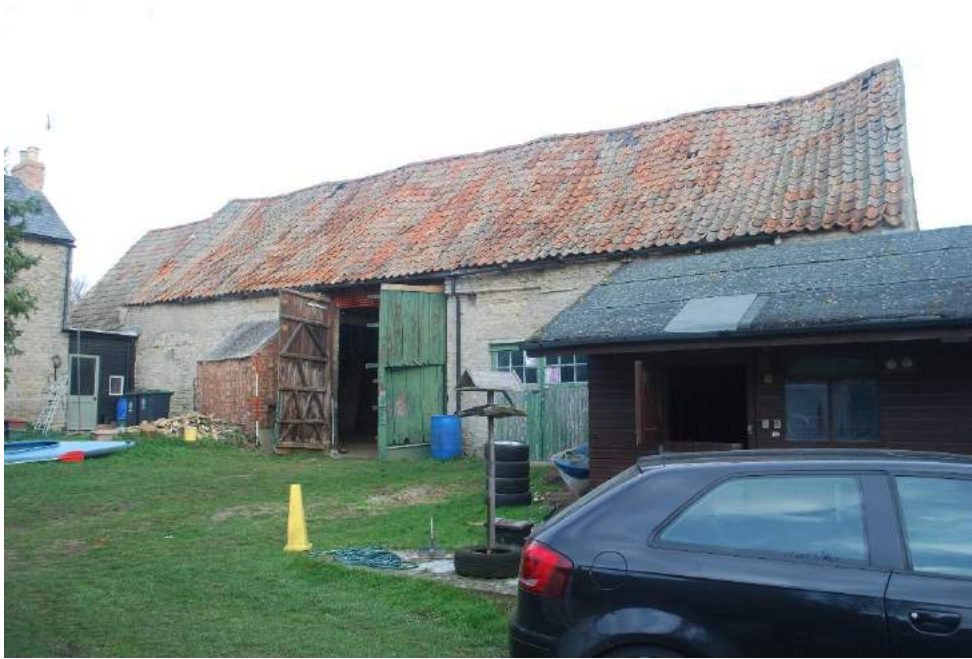
Figure 5: Barn, west side. Deflections in the roof due to the use of lightweight timbers can be seen.

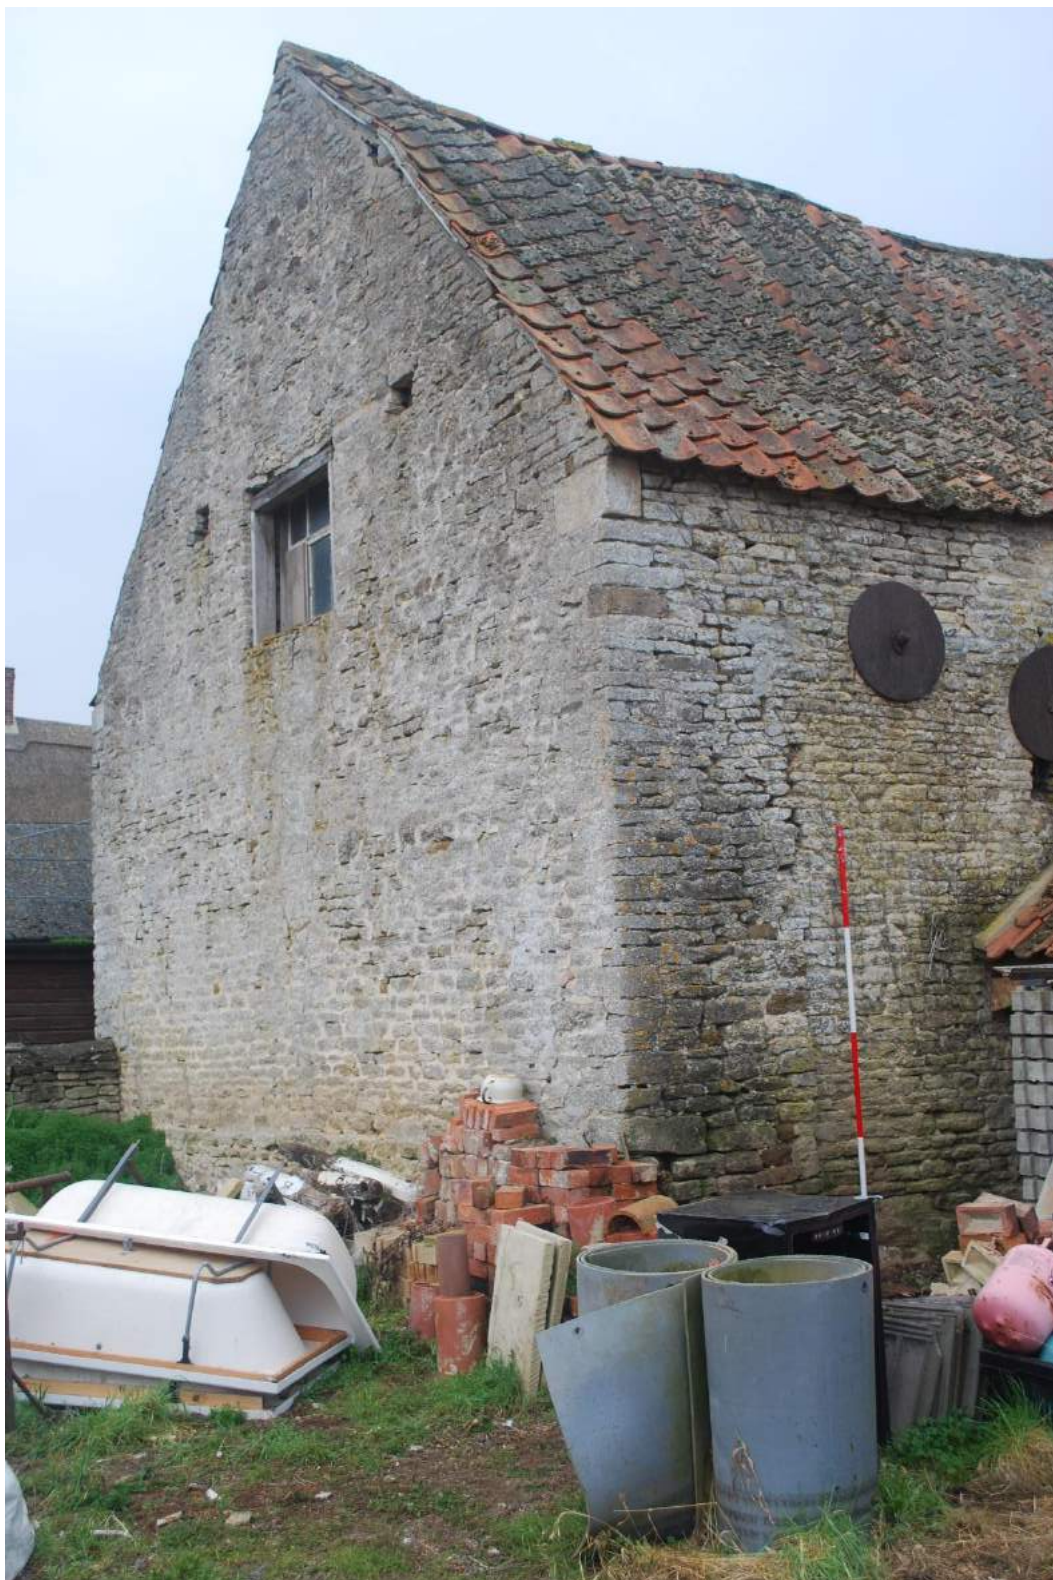
Figure 12: Barn, south-east corner. The gable wall, and the first metre of the side walls (see crack just to left of ranging rod), were rebuilt after a structural failure in the 19th century. It is hard to assess if the two tie rods were inserted before or after this, or as part of the same repairs. Note ventilation slit under right-hand tie-plate.

Probably relatively early in the barn's history there was a catastrophic failure of the south gable wall, which probably collapsed. It, and the first metre or so of the side walls, were rebuilt in a somewhat crude manner (Figure 12). At some stage the adjoining length of the east side wall developed a serious bulge, and two tie rods were inserted, one passing through a ventilation slit, which was blocked around it (Figure 32).

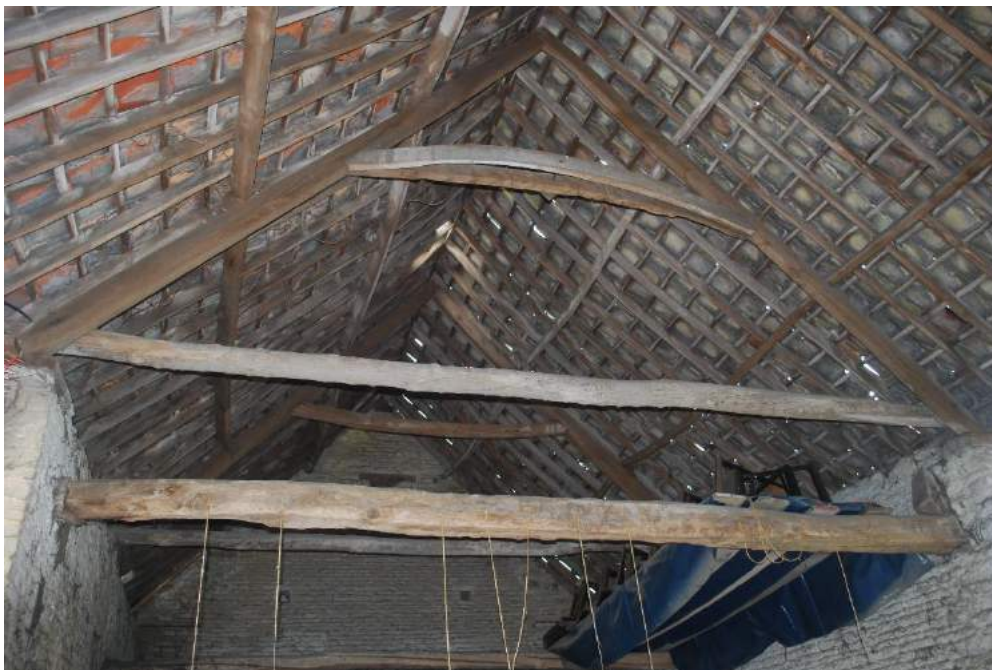
Figure 26: Looking north from bay 3, showing truss 3 (nearest camera) and truss 4. The generally lightweight nature of the roof timbers is clear. The larger beam set into the wall has no structural function. Such a beam is set beneath each of the four trusses.

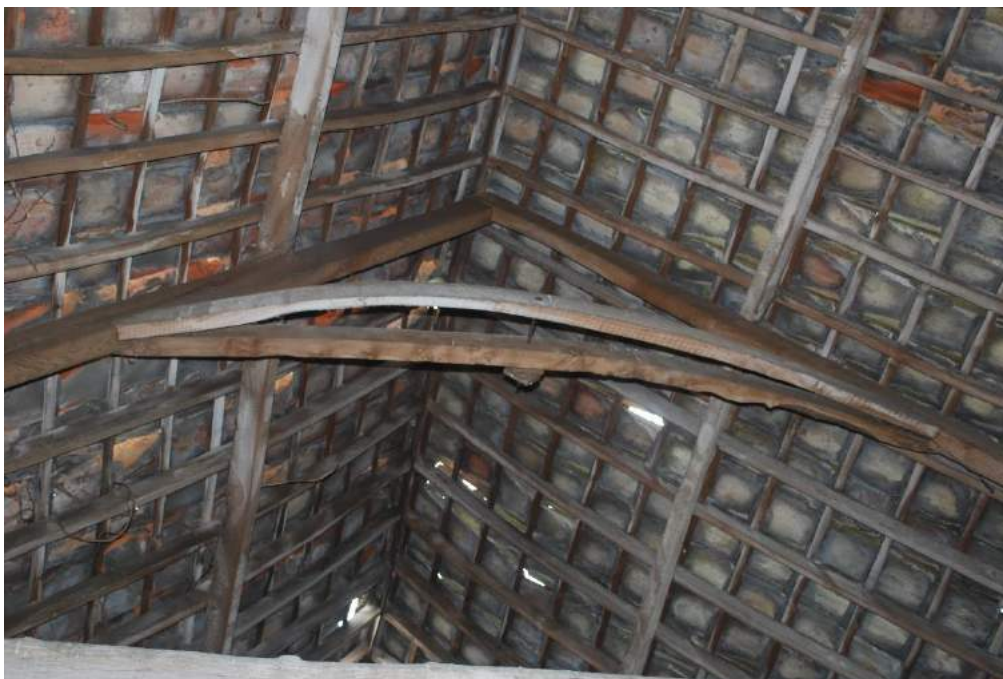
Figure 28: Truss 3, detail, showing deflection to collar (common to all four trusses) due to compression caused by the weight of the pantiles. An iron pin can be seen joining it to an inserted secondary collar.

The barn was wholly reroofed in the mid-19th century with machine-sawn timbers, other than for the tie beams (fixed to the bases of the principal rafters by iron spikes) where recycled timbers were used (see e.g. Figure 26). The new timbers were overly lightweight, and over time the roof has deflected as shown in a number of the photographs. At the same time the southern two bays (1 and 2) were separated with a brick wall from the rest of the barn (Figure 29). A new door was provided in the east wall of bay 2 for access (Figure 11).

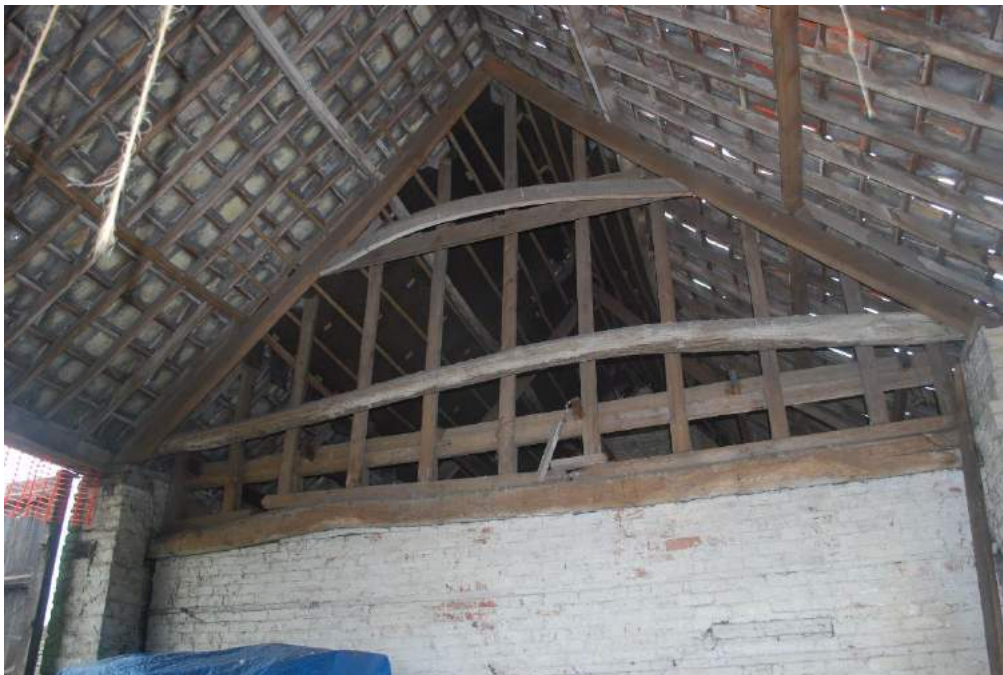
Figure 30: Bay 3, truss 3. The vertical timbers helped separate off the two end bays. The deflected collar, common to all trusses, is clearly visible.

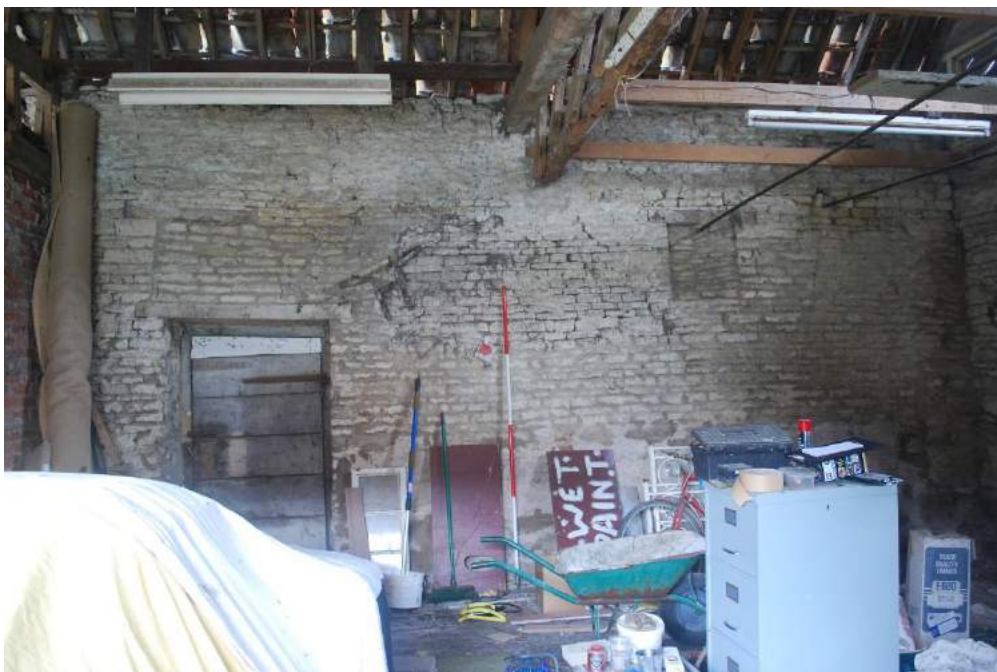
Figure 32: Bays 2 (to left) and 2, east wall, showing door with blocked window (perhaps a ventilation slit) above. Another blocked window (here certainly a ventilation slit) is to the right, now with a tie rod through it.

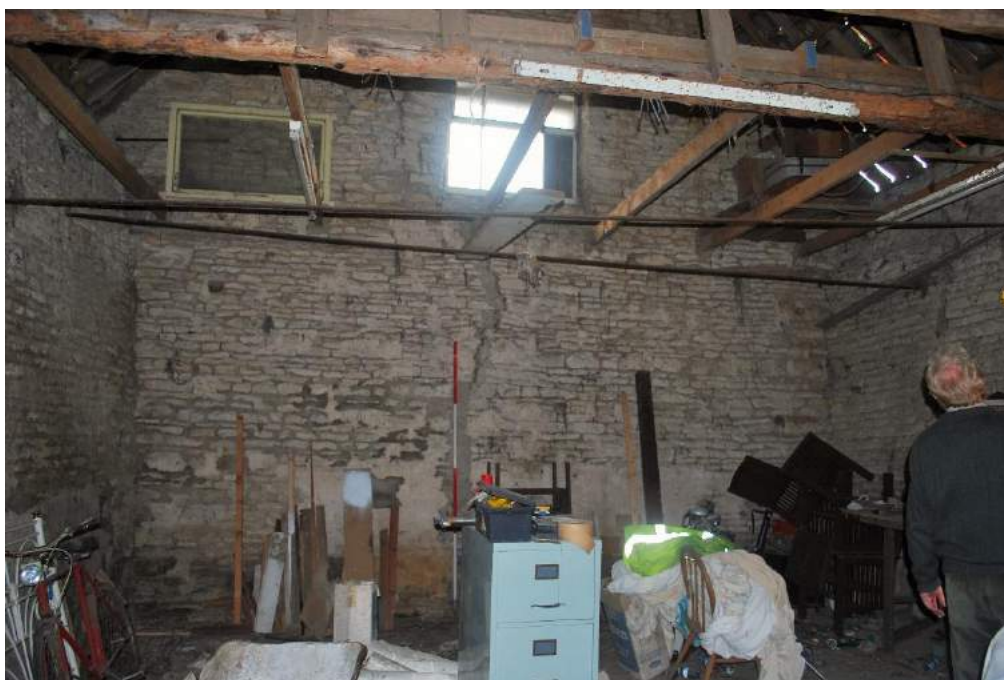
Figure 33: Bay 1, south gable wall. Note the large vertical crack to centre.

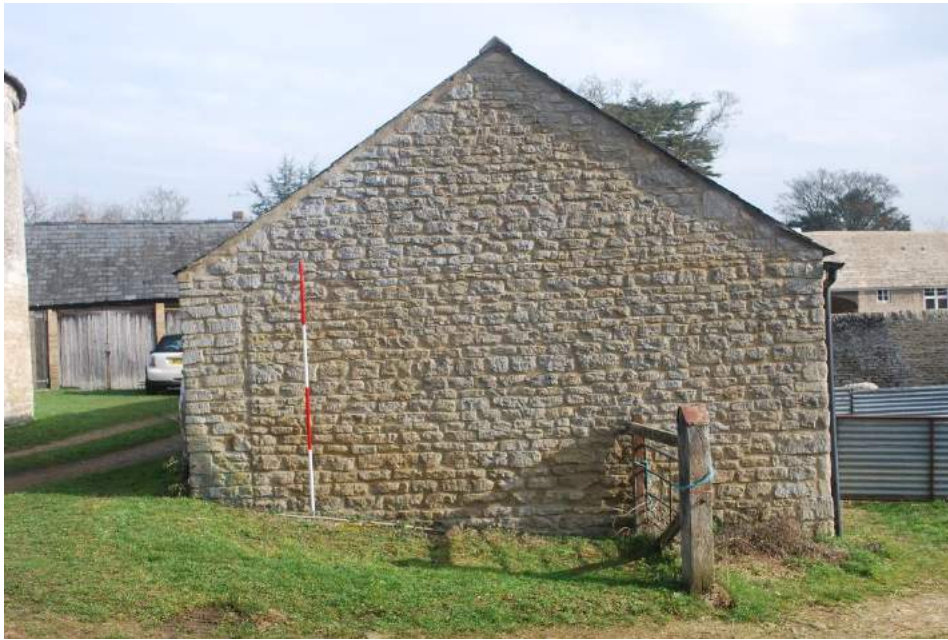
Figure 40: Stables, west gable wall. Note break in fabric to left of ranging rod.

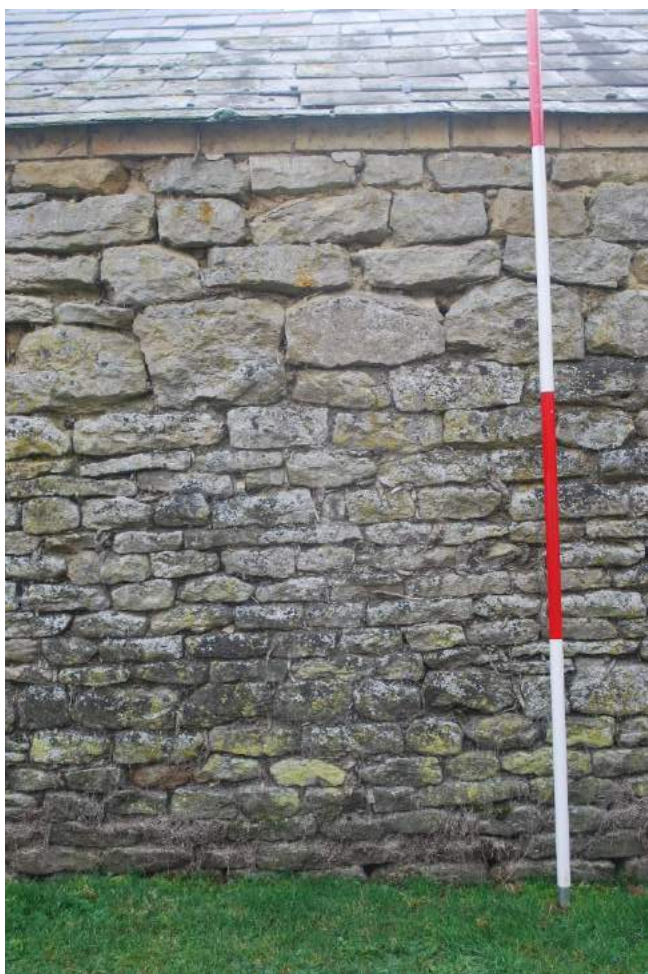
Figure 42: To centre of rear, north, wall showing raised or rebuilt upper courses.

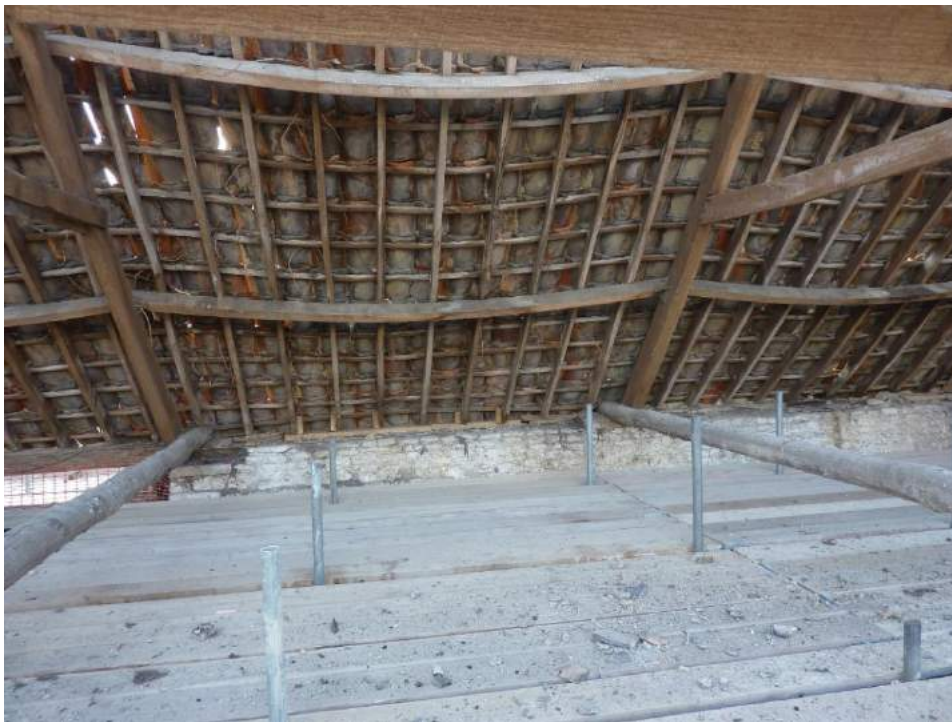
Addendum Figure 1. View east, centre of barn, showing flexed purlins.

Removal of the pantiles showed more clearly the extent to which purlins and braces had flexed under compression from the weight of the pantiles. No other details were noted.

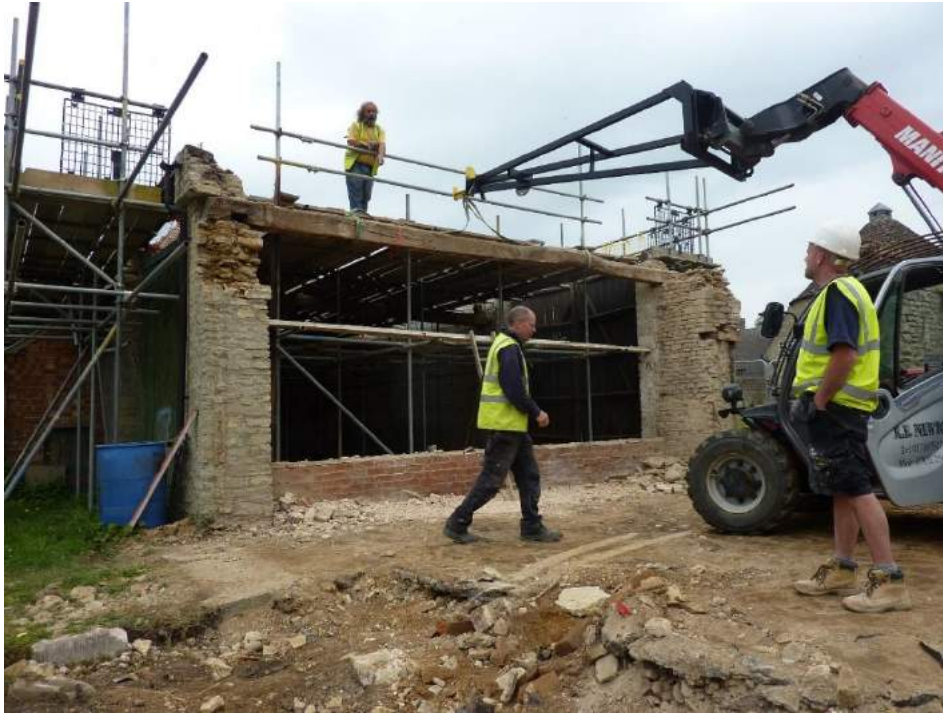
After removal of the roof timbers at the north end of the barn, and demolition of the unstable gable wall, it became clear that the first sections of the side walls were in a worse condition than had been appreciated. The walls of bays 1 and 2 were demolished to ground level, as was the inserted brick partition wall.

Addendum Figure 2. View from north-east across demolished bays 1 and 2. The partition wall has been largely removed, and the double doors can be seen beyond.

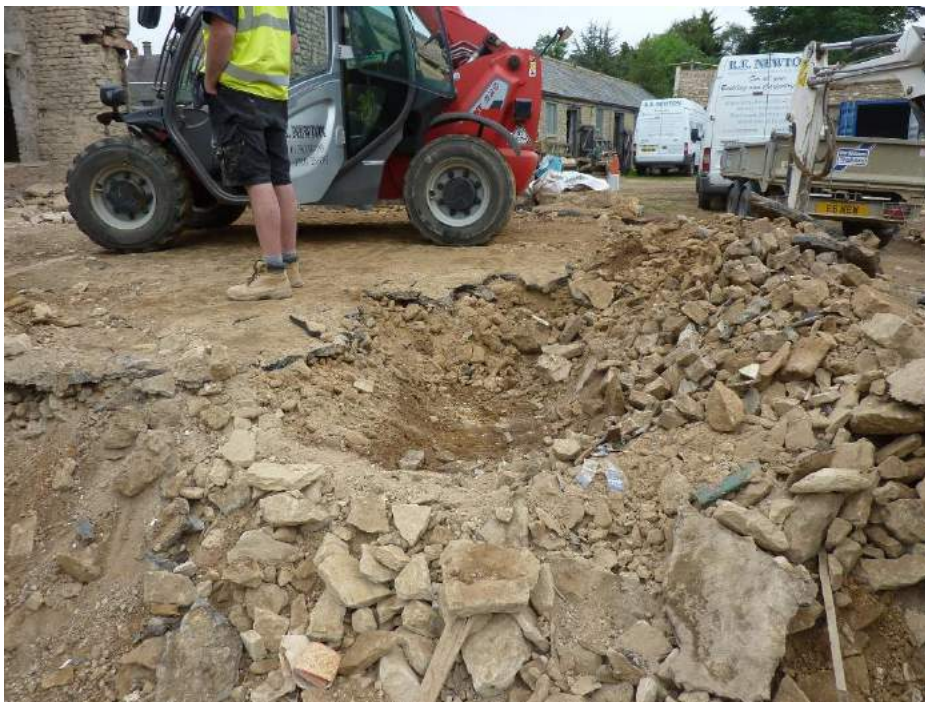
The floor level in bays 1 and 2 proved to have been raised by c.600mm in the 20th century with rubble and an asphalt skim, probably when this end of the barn was converted to a garage c.30 years ago (cf. Figure 13).

Addendum Figure 3. To show nature of raised floor in bays 1 and 2.
