**ARCHAEOLOGICAL BUILDING
RECORDING OF A BARN AND STABLE BLOCK AT DOVECOTE, PILTON
ROAD, WADENHOE,
NORTHAMPTONSHIRE**

**A Report by Paul Stamper Heritage
March 2019 (with Addendum July 2019)**

The Wadenhoe Trust has been granted LBC (18/02319/LBC) to convert a stone barn into office accommodation and a stable into a dwelling. Both adjoin Wadenhoe's Grade II-listed dovecote and lie within Wadenhoe's conservation area. Paul Stamper Heritage was commissioned by the scheme's architect Colin Moore on behalf of the Trust to undertake Level 2 recording work as set out in a WSI approved by NCC following a brief issued by NCC dated 31 January 2019.

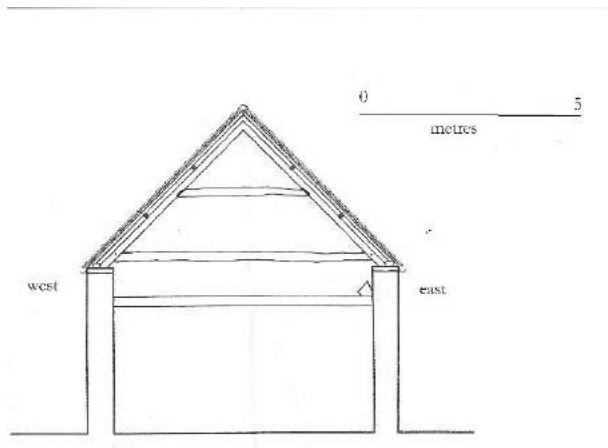
Figure 3: Barn, section at truss 3, south face (annotated architect's drawing).

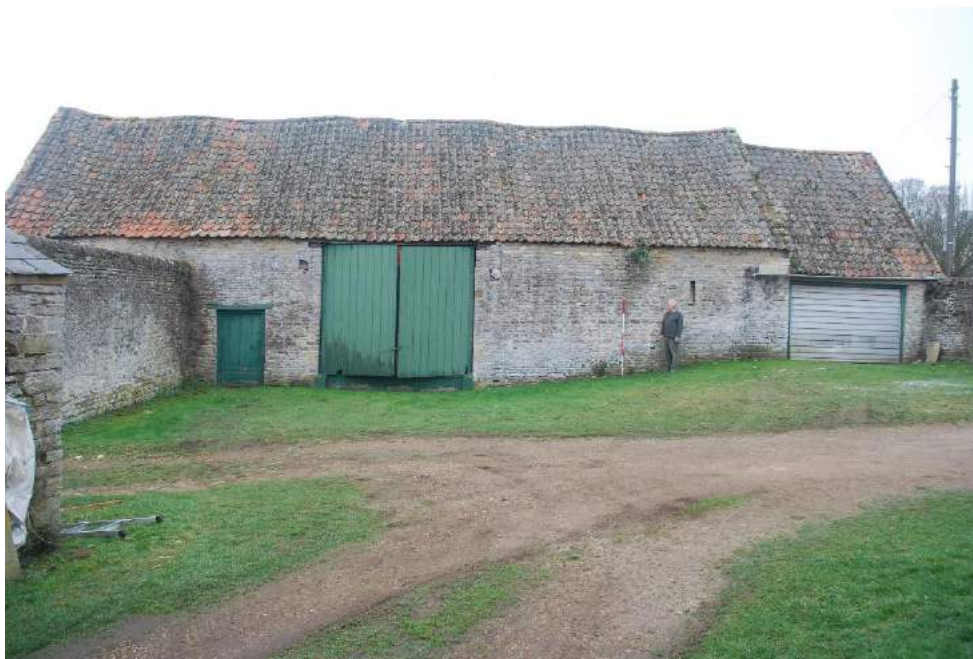
Figure 4: Barn, east side; Pilton Road is to the right. The later extension can be seen on the right, with the pigsty range running out from the barn to the left. The listed dovecote is behind the photographer.

The date of the addition to the north end of the barn (Figures 4 and 19) is unknown, although as it is wholly of stone (no brick is used) this suggests a relatively early date, probably before the mid-19th century. The roof is modern. Its original function is uncertain; latterly it was used as a garage, with an inserted up-and-over door. It is possible that it was always used for vehicle storage. There is a small fireplace in the south-west corner, and there is a considerable amount of pencilled graffiti on the plastered north and south walls. Much is so faint or worn that it is illegible, but subjects include notable local events (e.g. Figures 34-5); exceptional weather; lists of names; and tally marks, sometimes referencing 'quarters' associated with getting in the harvest. Where dates are given, they are mostly in the second decade of the 20th century.

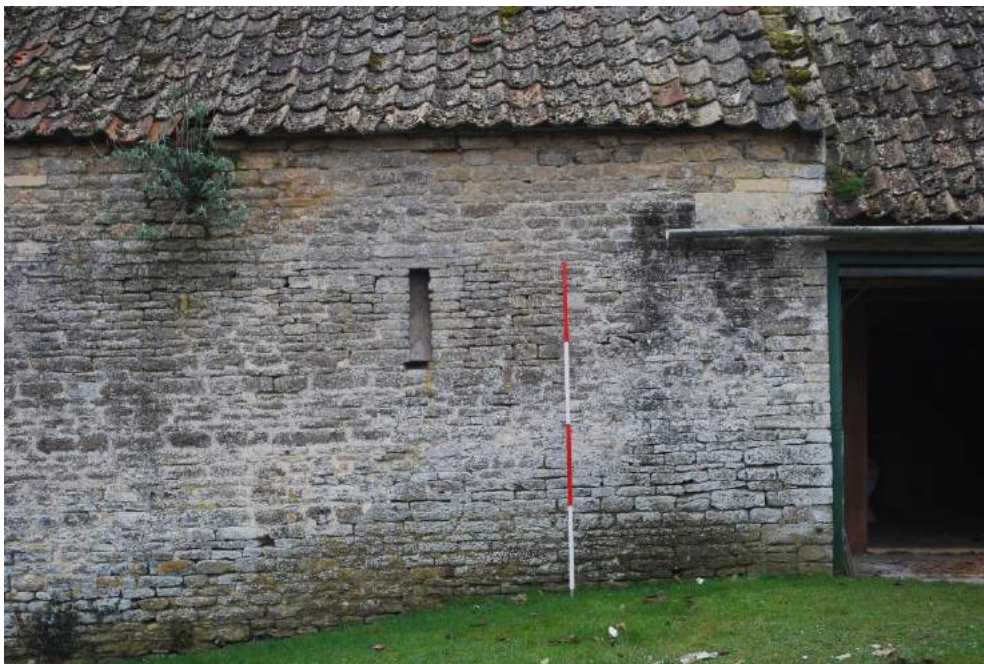
Figure 6: Barn, east side, bay 5. Note ventilation slit.

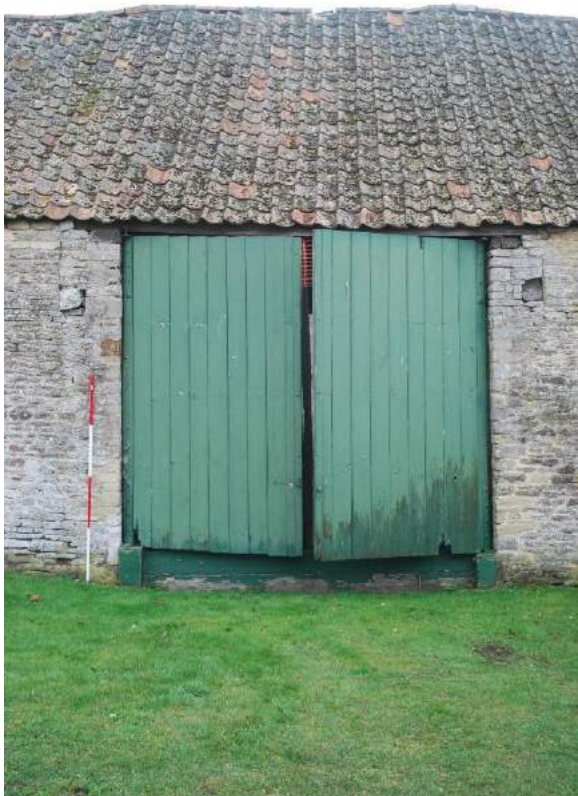
Figure 8: Barn, east side, bay 3, double doors closed.

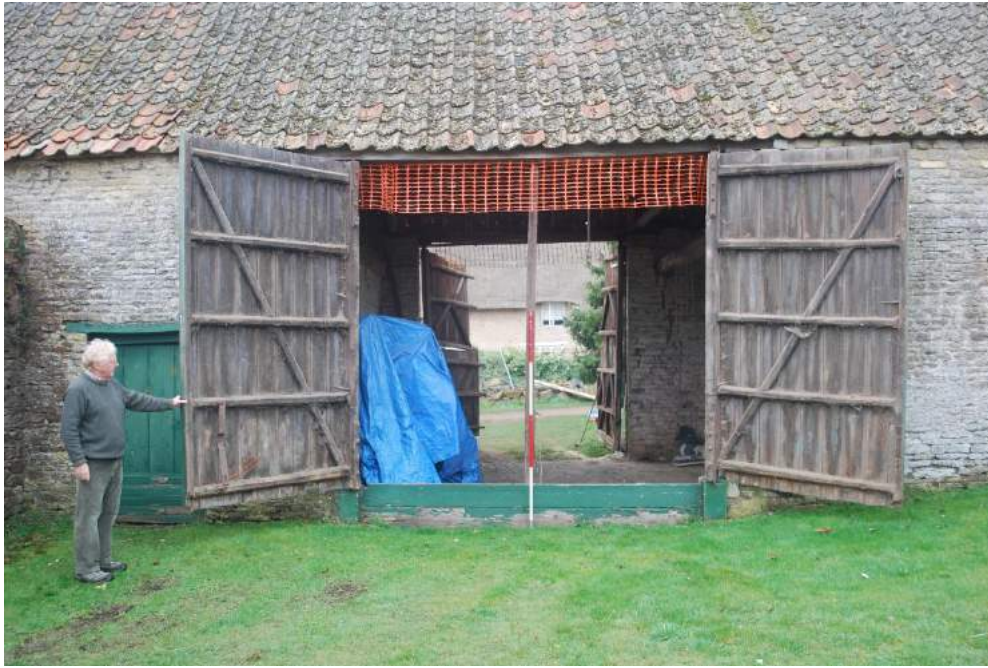
Figure 9: Barn, east side, bay 3, doors open. The doors are probably from the first half of the 20th century.

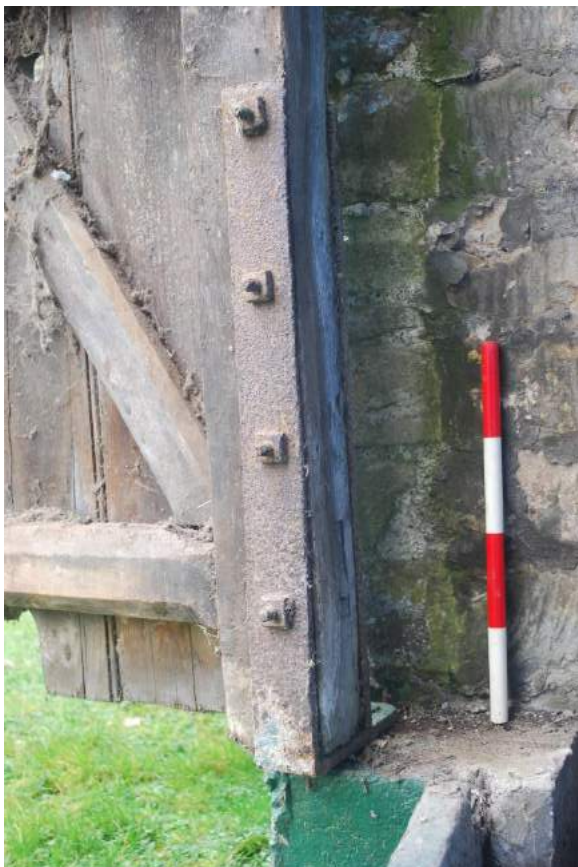
Figure 10: Iron hinge to base of southern door. Note the concrete posts which both east side doors are set on.

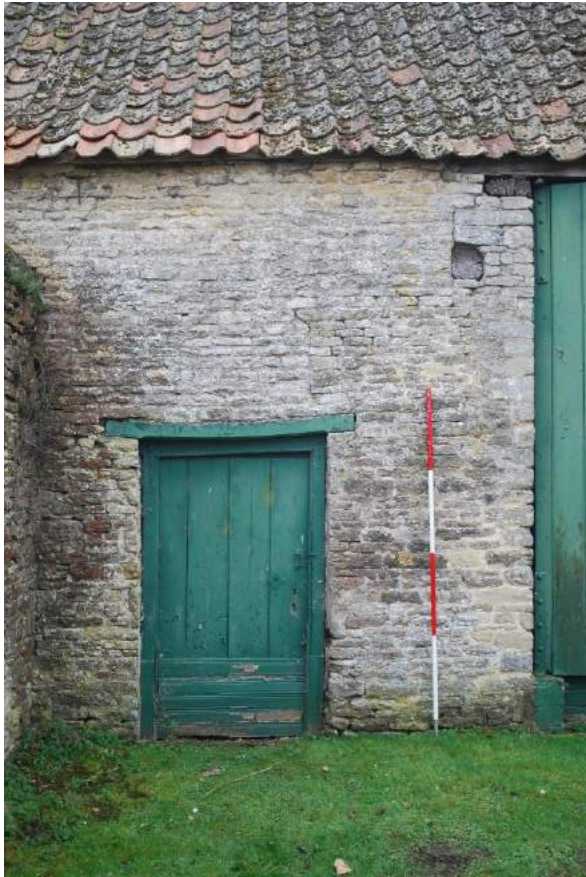
Figure 11: Barn, east side, bay 2. The door is a 19th-century insertion. Its introduction led to the blocking of a window above, itself an insertion. Large-scale OS mapping shows bays 1 and 2 (which the door gives access to) were already divided off by the 1880s.

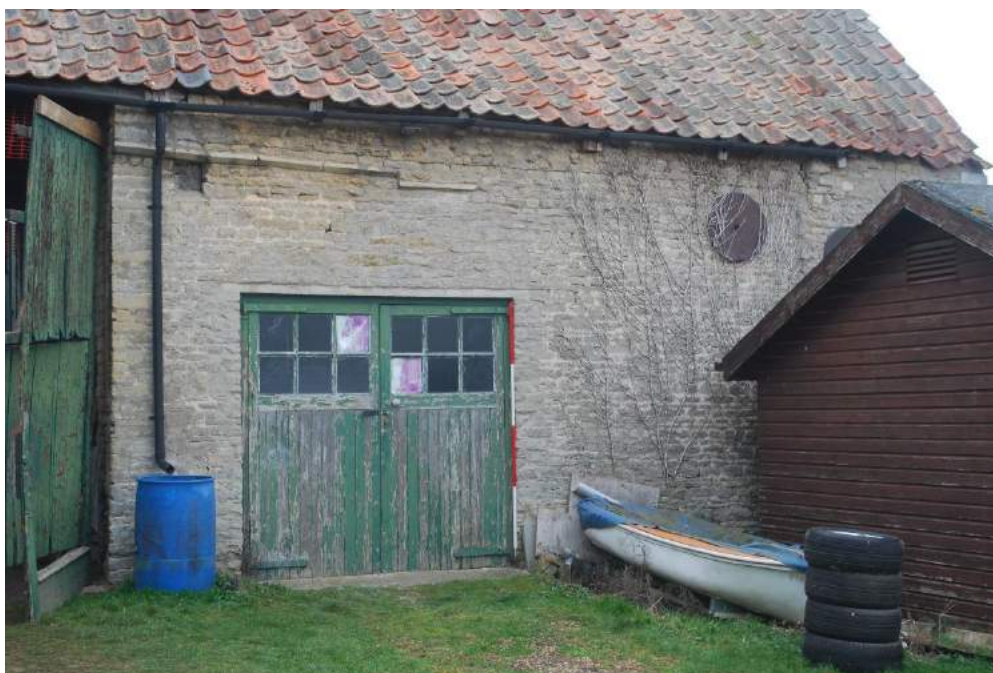
Figure 13: Barn, west side, bays 1 and 2. The garage doors were inserted c.30 years ago.

The final change to the structures came c.30 years ago (that is in the later 1980s) when a double garage door was created leading in to bay 2 on the west side of the barn (Figure 13).

The floor level in bays 1 and 2 proved to have been raised by c.600mm in the 20th century with rubble and an asphalt skim, probably when this end of the barn was converted to a garage c.30 years ago (cf. Figure 13).

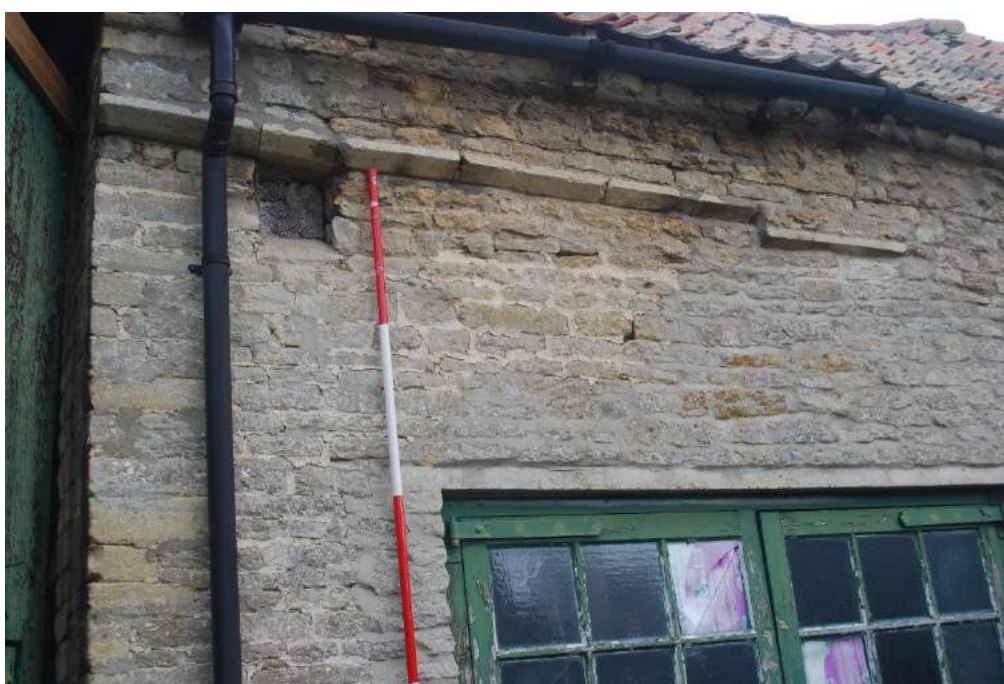
Figure 14: Re-used chamfered stone above garage door. Perhaps introduced when the upper courses were rebuilt at reroofing in the mid-19th century.

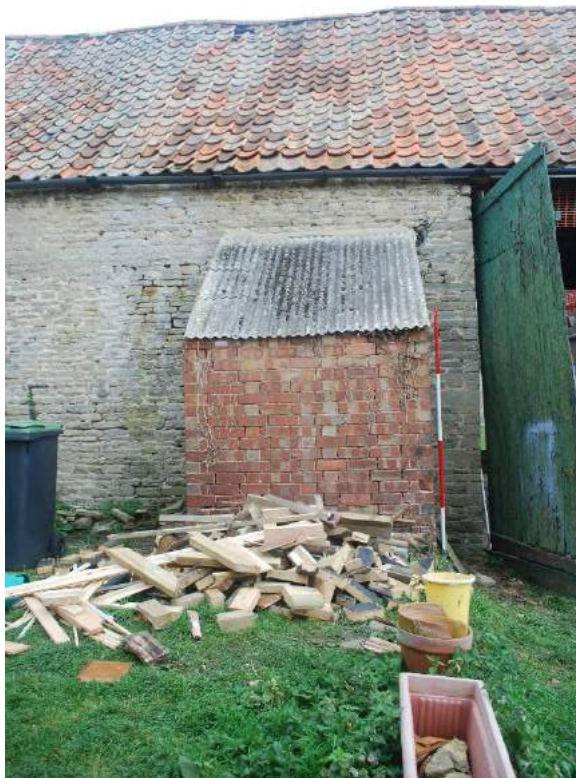
Figure 16: Barn, west side, bay 4. Mid-20th century brick privy.

In the mid-20th century a brick privy was built against the south side of the barn for the cottage on Pilton Lane to the west of the barn (Figure 16). Its construction led to the blocking of the inserted window into the barn.

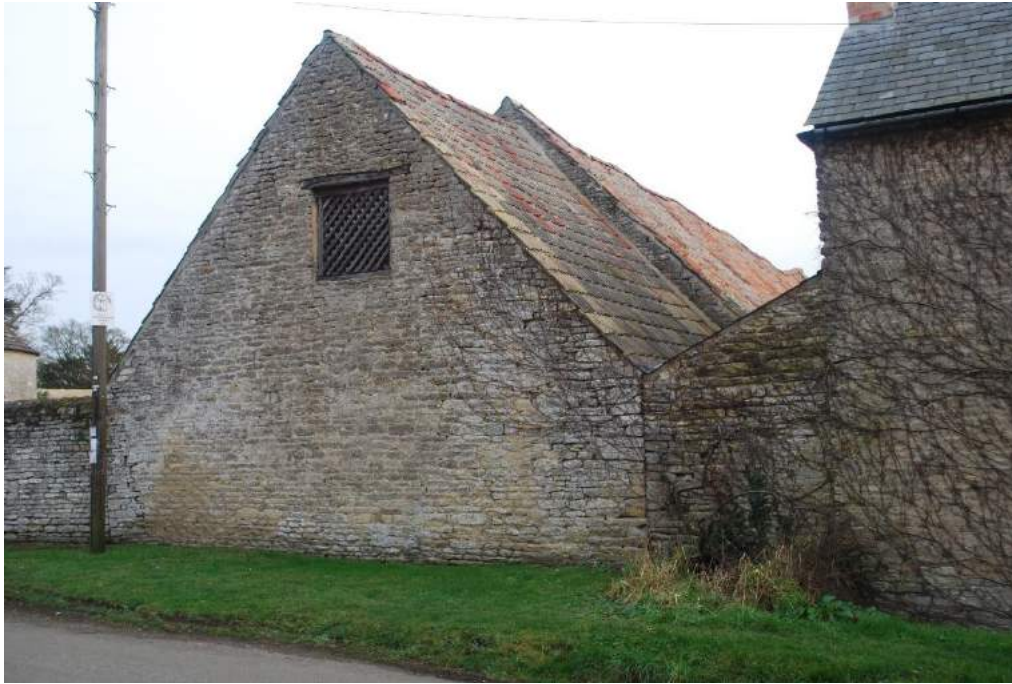
Figure 19: View from Pilton Road to the one-bay addition to the barn. This has virtually no diagnostic features but is likely to be from the decades either side of 1800.

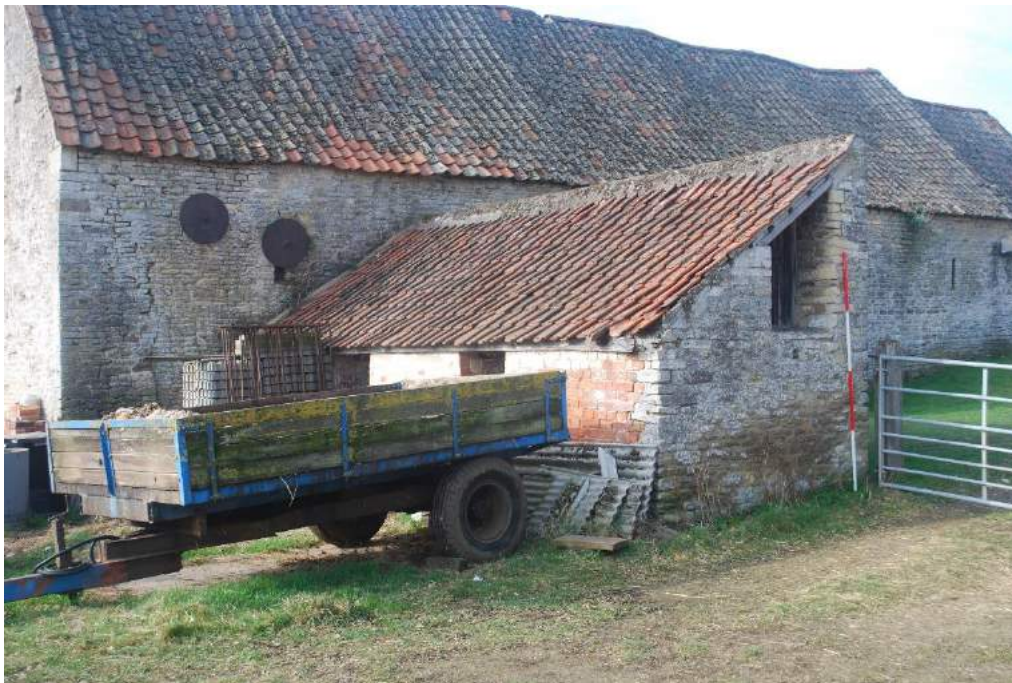
Figure 20: Pigsty range from south-east. Probably mid-19th-century, and mapped in 1886.

It was also in the mid-19th century that the stone-and-brick three-unit pigsty was built against the south end of the east side of the barn (Figures 20-2). Chickens had access to the interior

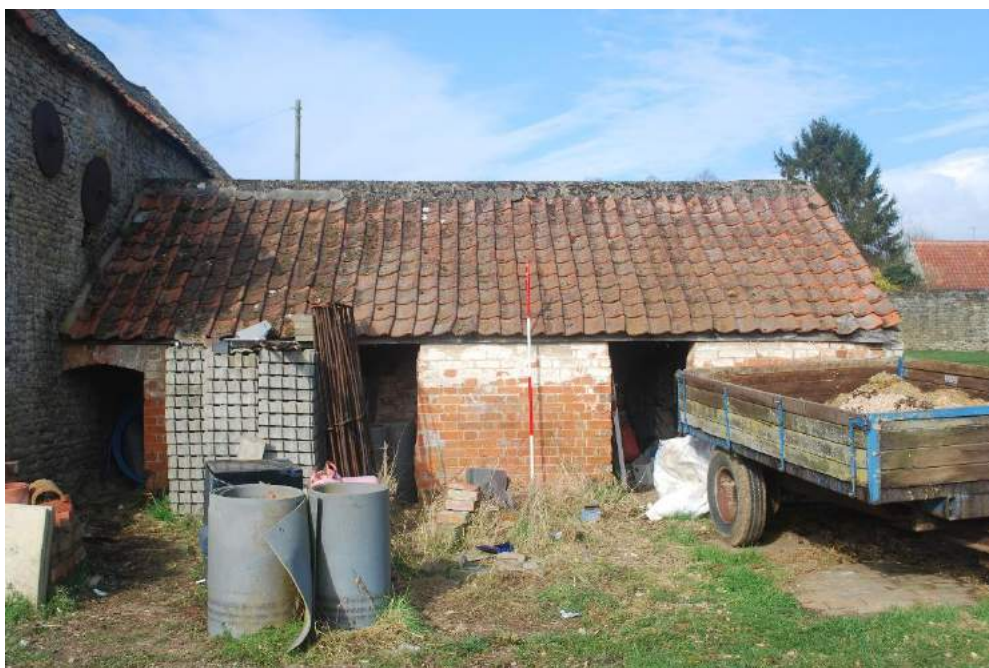
Figure 21: Pigsty range, south face. Note the one surviving round-headed arch to the left.

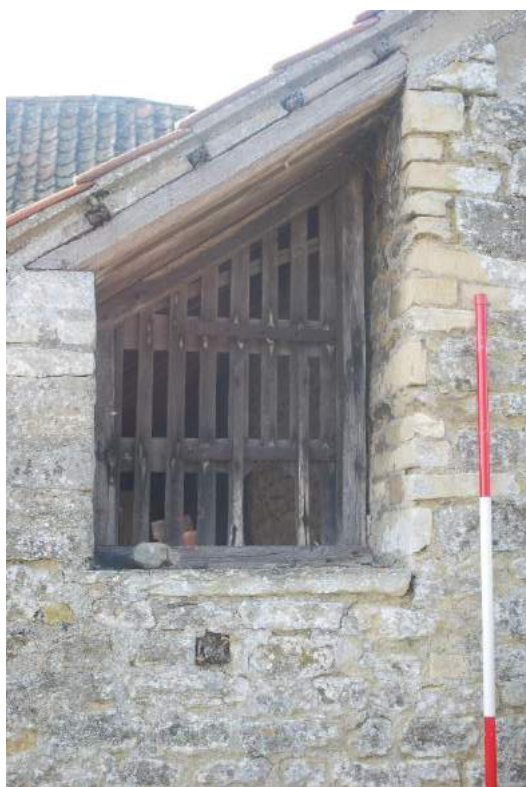
Figure 22: Window with hatch for chickens in east gable wall of pigsty.

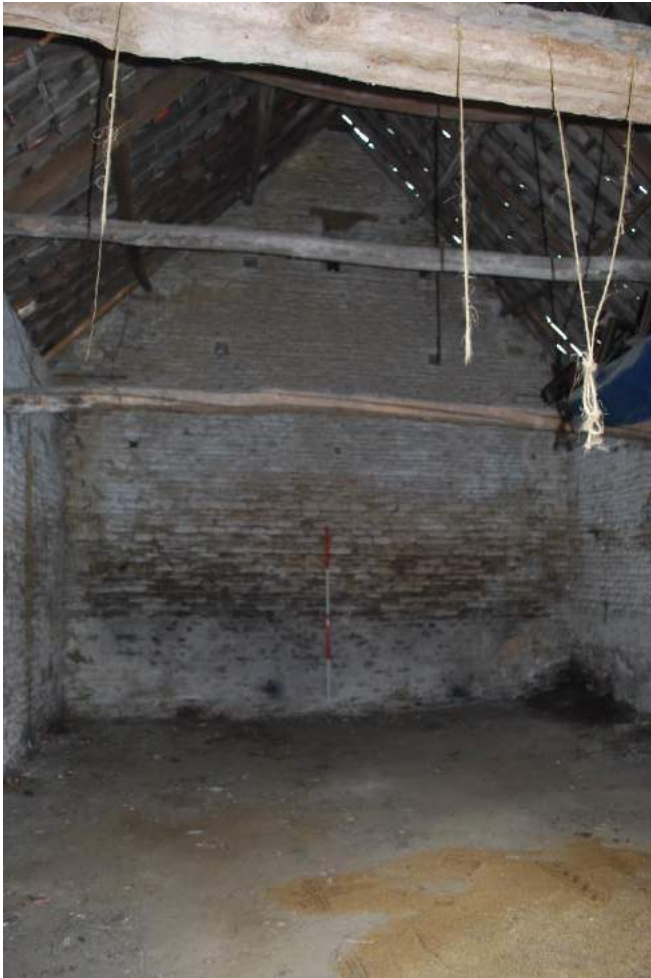
Figure 23: Barn, bay 5, north gable wall. Possible floor joist holes are either side of the ranging rod.

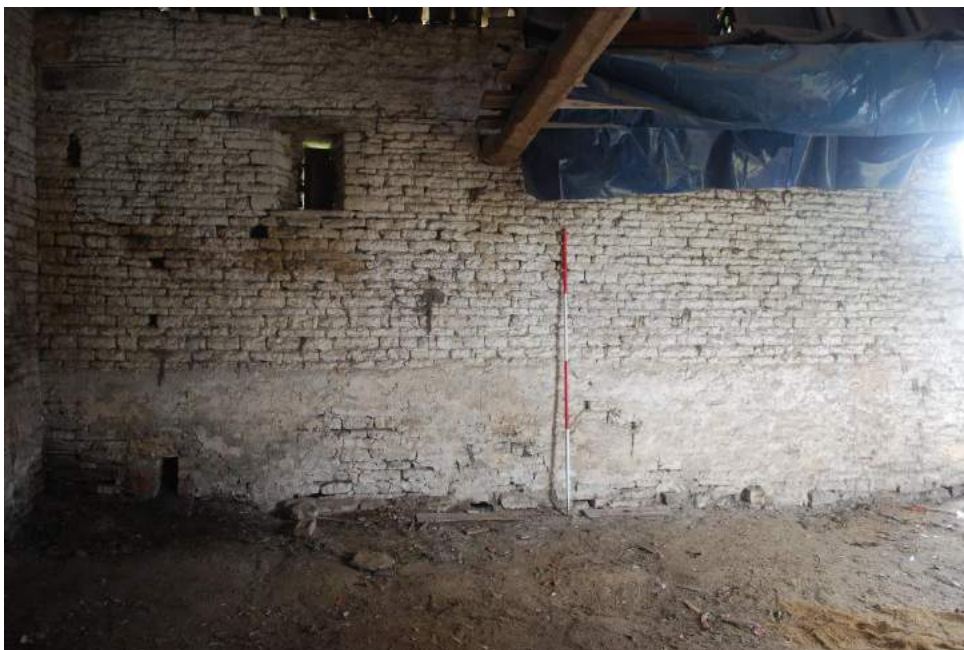
Figure 24. Barn, bays 4 and 5, east side, showing (a) splayed inner side of ventilation slit (b) plastered lower section of wall and (c) possible floor joists to right of ranging rod.

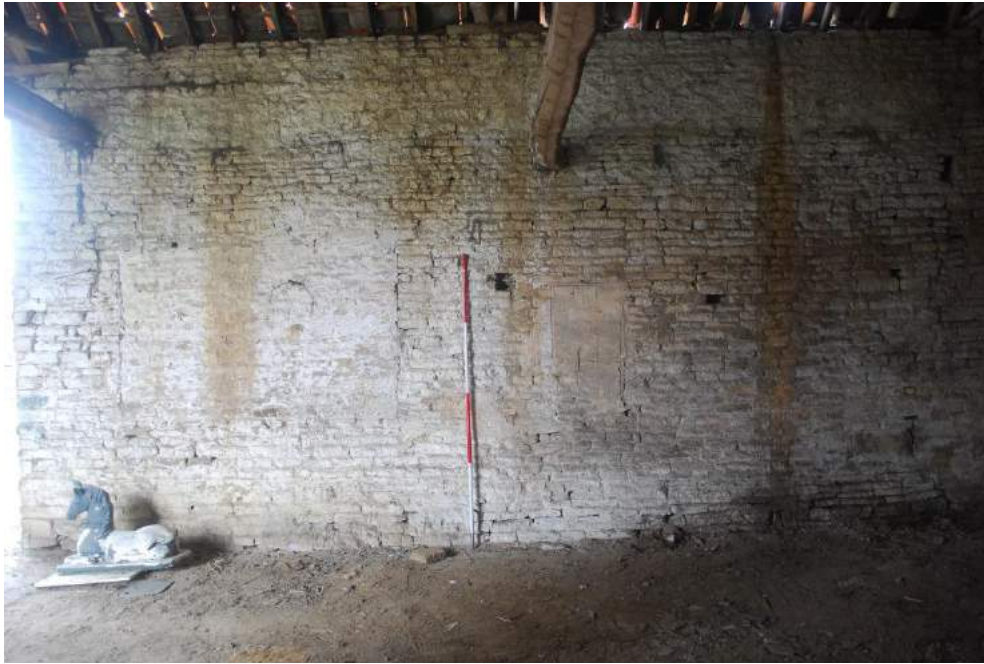
Figure 25: Barn, bays 4 and 5, west side, with blocked window left of ranging rod.

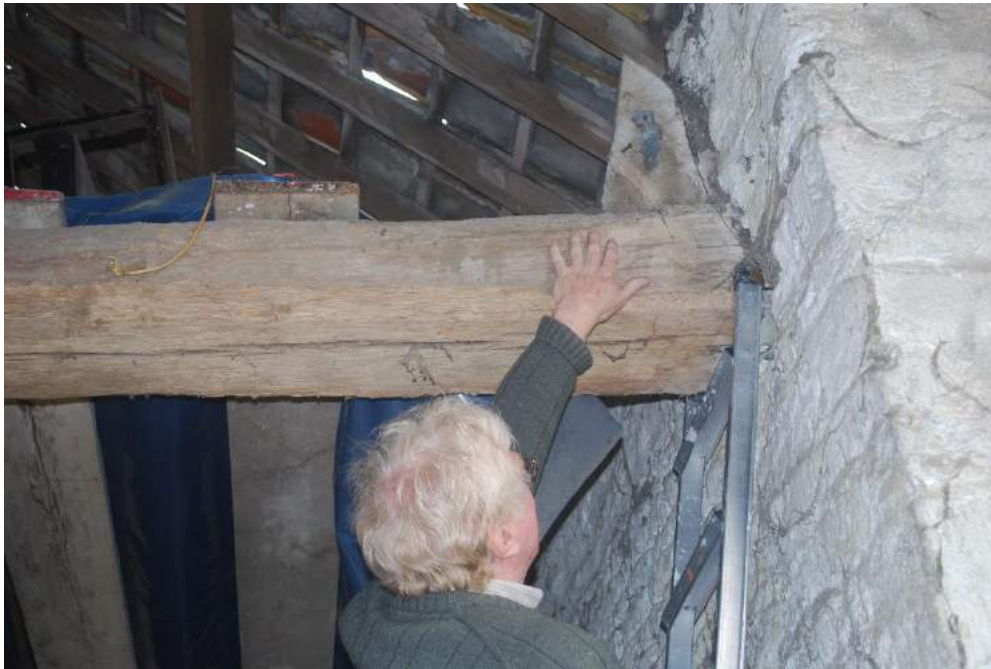
Figure 27: Large re-used beam beneath truss 3, east end, south face, to show sawn-off principal rafter.

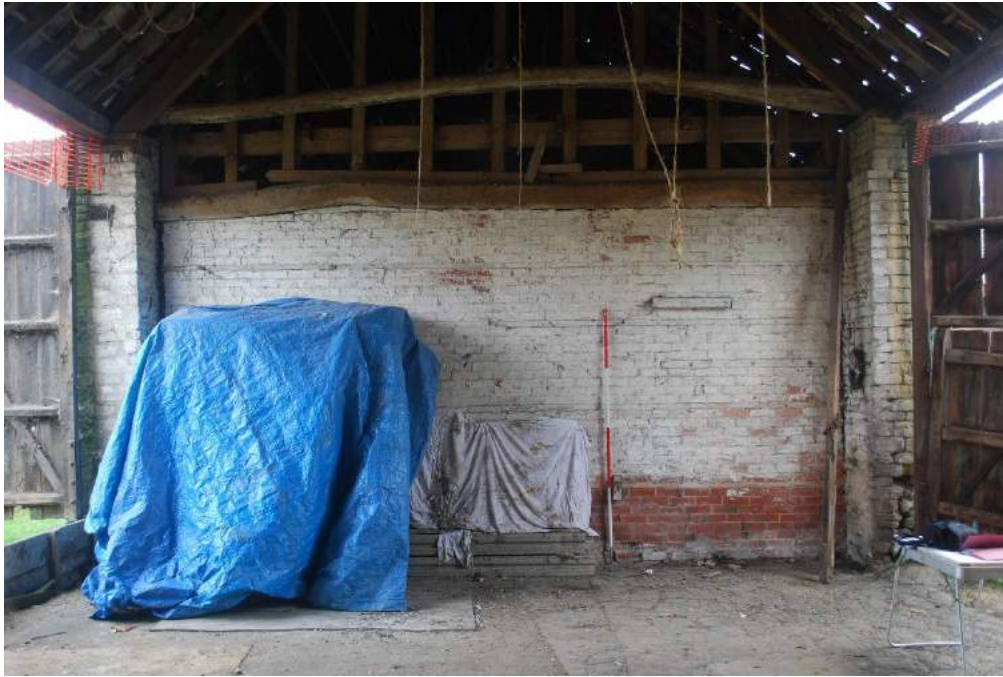
Figure 29: Bay 3, south wall. This wall is of mid-19th-century date, and was inserted when bays 1 and 2 were separated off. Again, the beam above it which the brick wall abuts has no structural function.

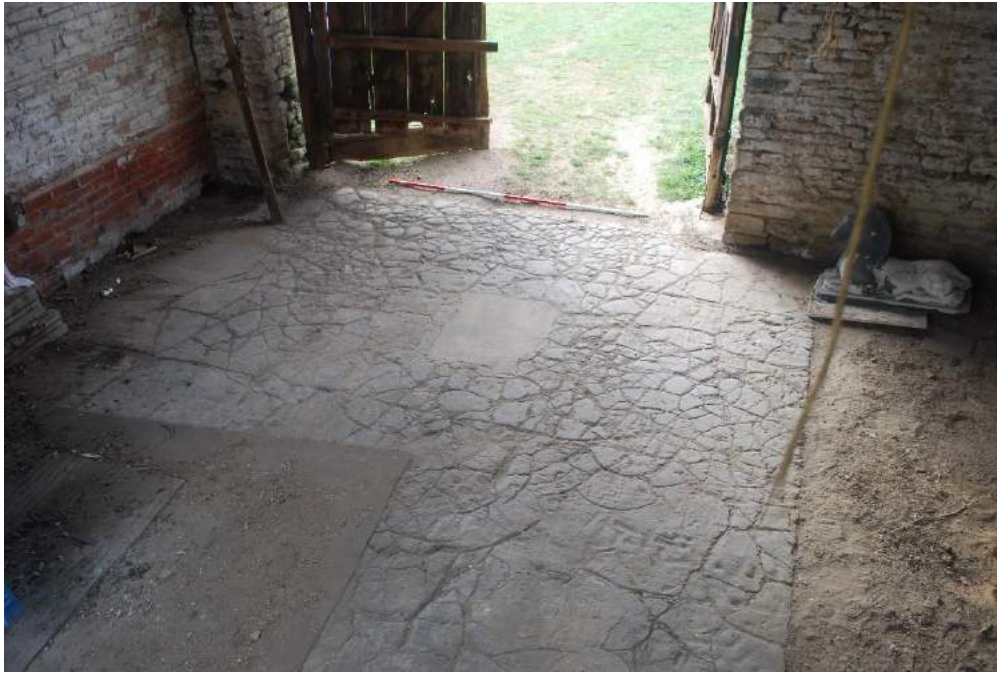
Figure 31: Bay 3, looking west over threshing floor.

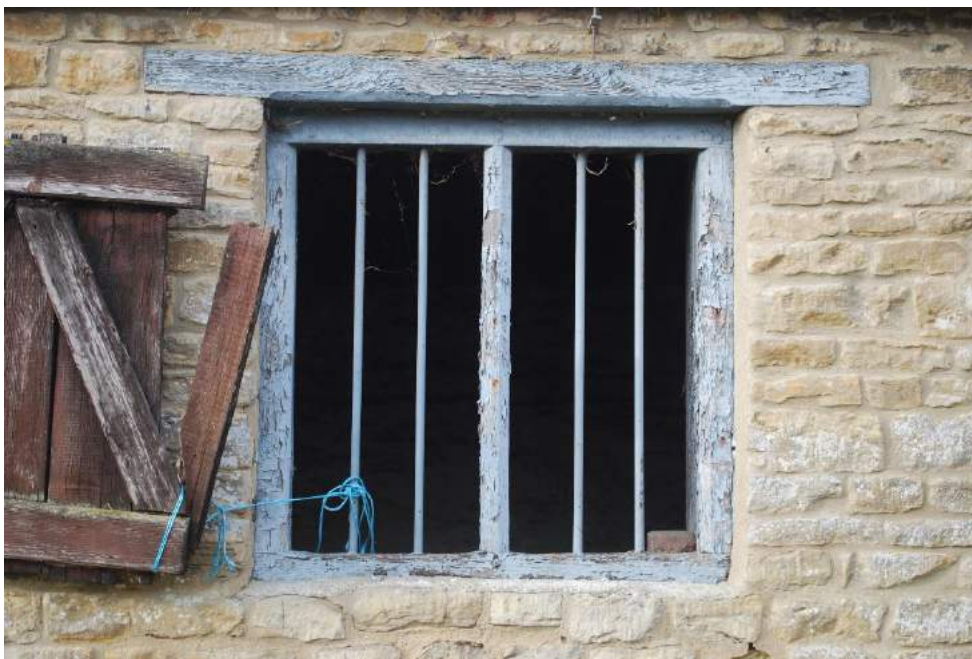
Figure 39: Stables east end window, south side.

As noted above, the stables range is probably mid-19th-century, possibly constructed off the lower walls of a pre-existing agricultural building. Confirmation that the range was built as stabling, rather than as loose boxes for cattle, is provided by the relatively large window openings (e.g. Figure 39). In 1886 the eastern three doors gave access to a small enclosed yard running down to the walled garden.

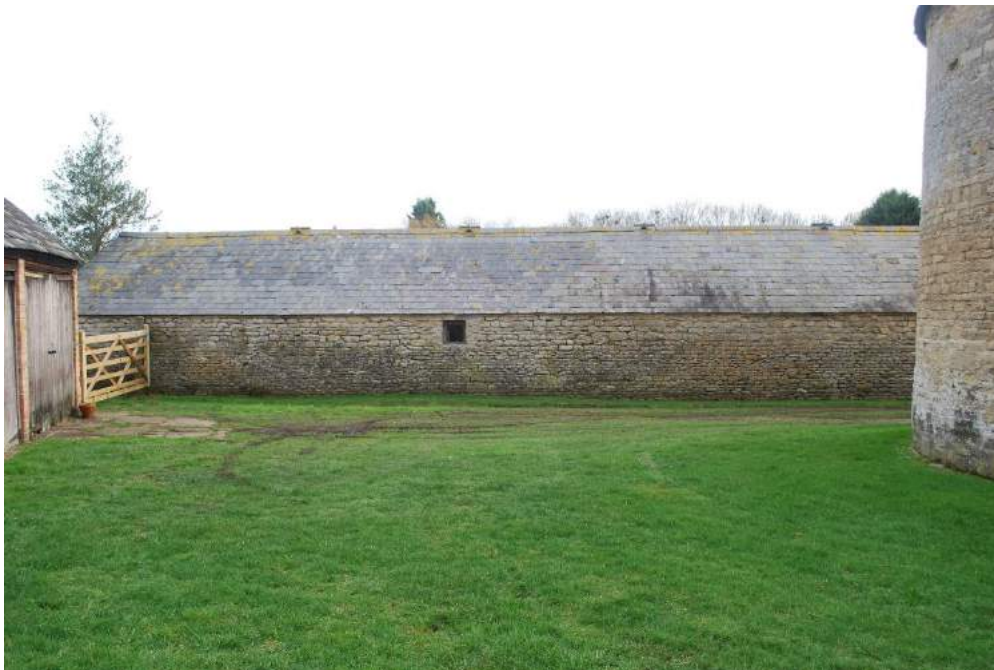
The stables range is of coursed limestone with a slate roof set on a roof frame of fairly lightweight machine-sawn timbers with angle braces rising to meet the purlins off the tiebeams. (Figure 41). It has maximum external dimensions of 23 x 5.3m, runs east-west, and stands just downhill from the Grade II-listed dovecote. It is marked on the 1886 25-inch Ordnance Survey map, and is probably of mid-19th-century date.

Figure 41: Stables, rear, north, wall.

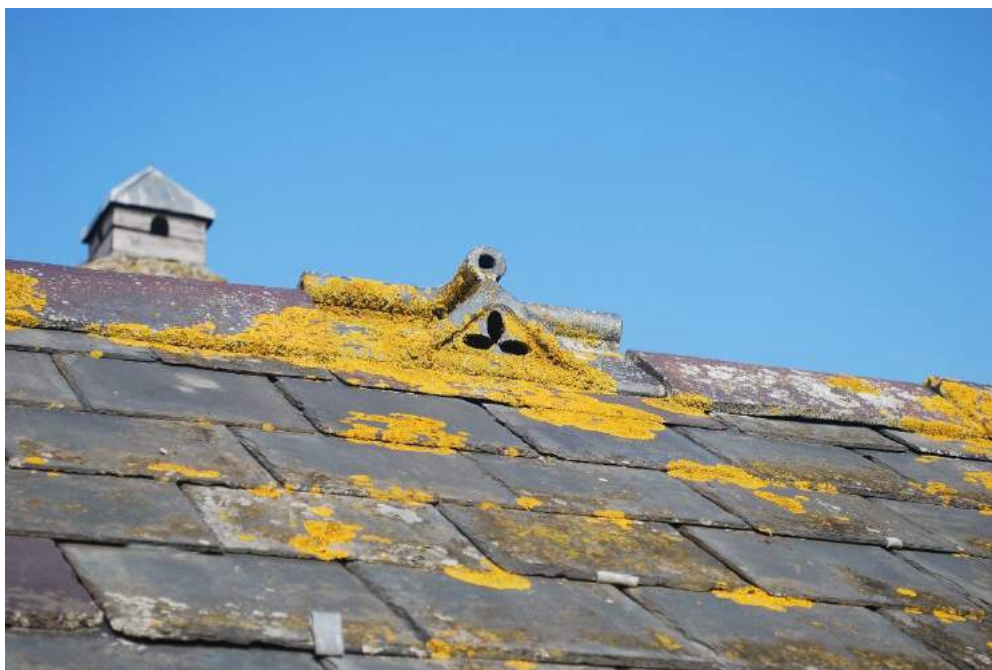
Figure 43: Four-ways roof vent (top of dovecote beyond).

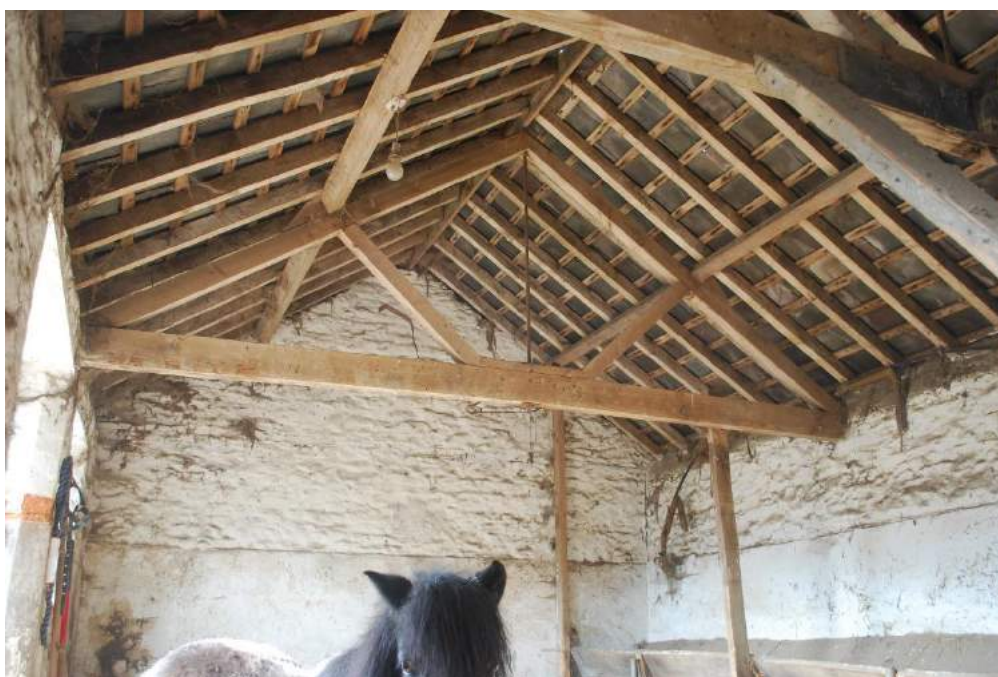
Figure 45: Stables, view west to gable, to show roof construction. Feeding trough and partitions are of relatively recent date.
